## PROPUESTA DE CAMBIOS EN LOS FORMATOS DE INSPECCIÓN DE PUENTES DE BOGOTÁ

### *PROPOSAL CHANGES BRIDGES INSPECTION FORMATS OF BOGOTÁ*

*Zulma Stella Pardo Vargas <sup>(1)</sup>*

<sup>1</sup> Universidad Distrital Francisco José de Caldas. Facultad Tecnológica.

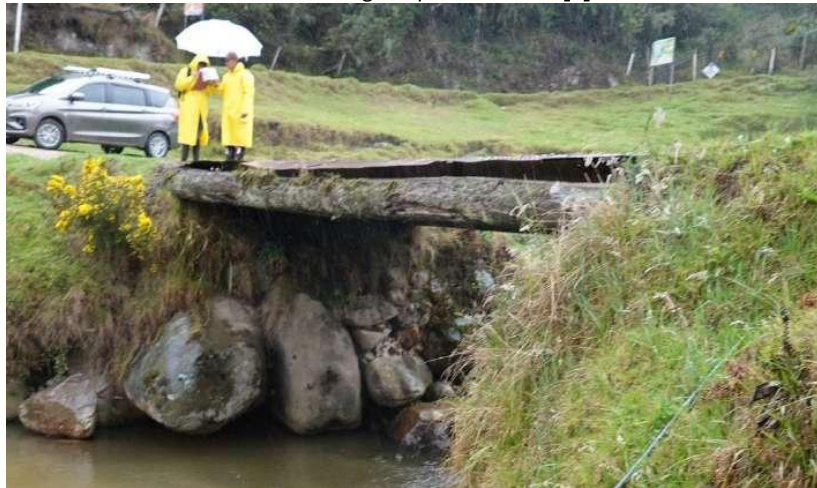
Source: ZJ Ingenieros Estructurales SAS. Rock supports a bridge. Beams in different materials

If the bridge lacks of abutment and it is supported in a rock, it is not possible to report it, the format lacks this option. [5] y [7]

If the bridge has beams in different materials, the format does not permit evaluated the different materials in the classification. The work group must decide which beam will report, only one material.

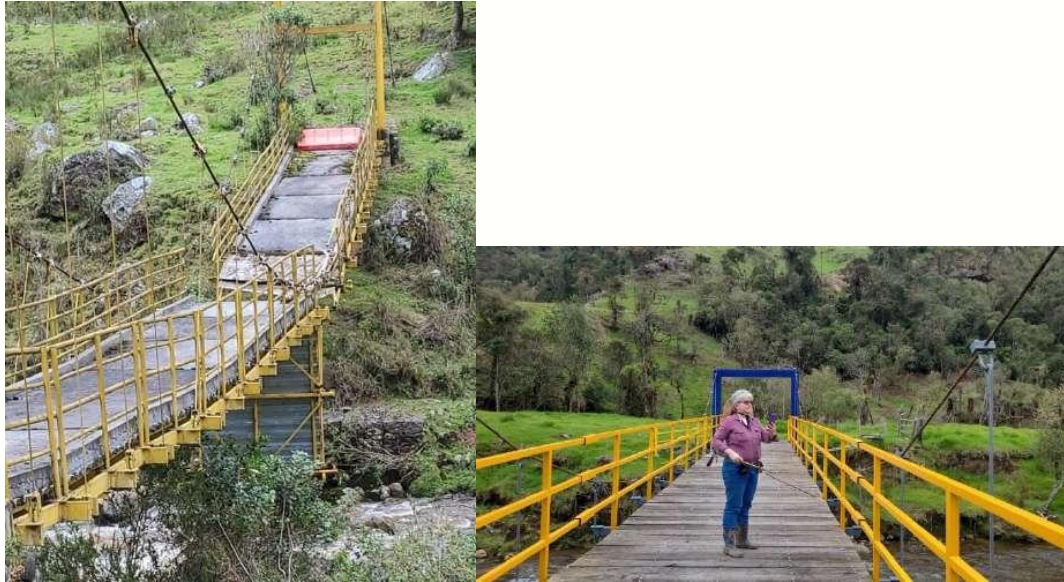
Some bridges in El Sumapaz are difficult to classify with these formats, as the followed in this pictures

**Source:** ZJ Ingenieros Estructurales SAS.

In the Category “Artesanal – vernacular”, are included so many typologies and can produce confusion in the decision makers to assign inversion budget.

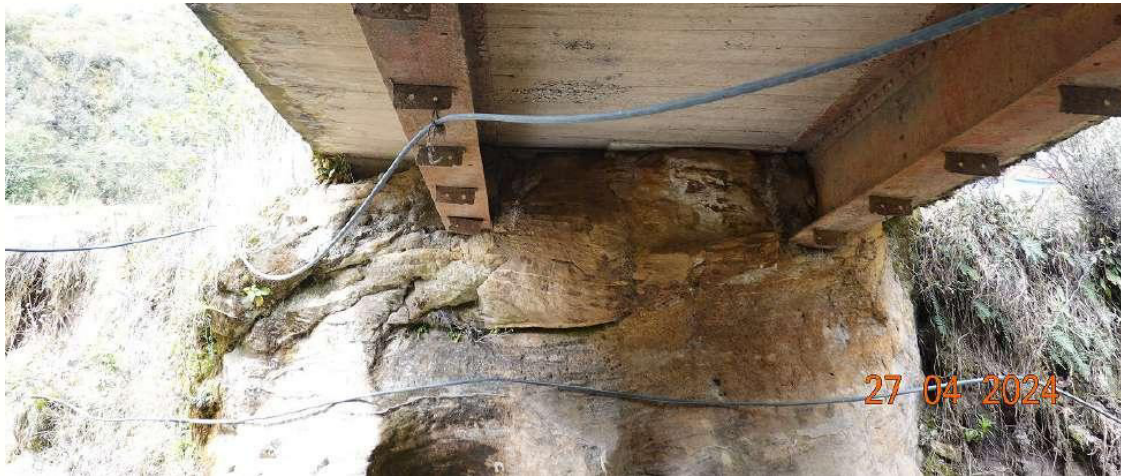
Source: ZJ Ingenieros Estructurales SAS. Rock supports a bridge.
